5 January 2016

RE: Field Activity Report
San Jacinto River Waste Pits
Remedial Investigation/Feasibility Study Oversight
Channelview, Harris County, Texas
Contract: EP-W-06-004
Task Order: 0130-RSBD-06ZQ

**FIELD ACTIVITY REPORT
23 AND 28–31 DECEMBER 2015
SAN JACINTO RIVER WASTE PITS
CHANNELVIEW, HARRIS COUNTY, TEXAS**

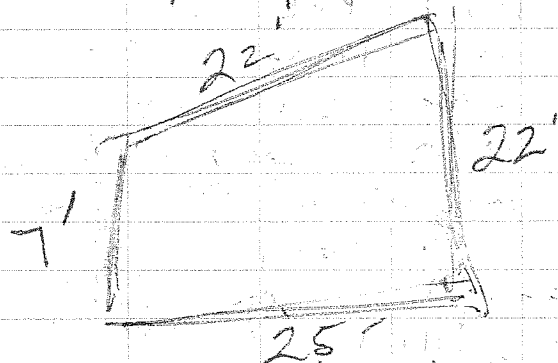
10:30 - Benchmark Environmental
(sub to Anchor) arrives by boat
to location of damaged area11:00 - Start process of staking
damaged area ~~at~~ boundaries

with PVC piping as follows:

- 12:00 - Longhite striking damaged area (photo)
 12:02 - boat leaves area to pick up sample kit from boat launch
 12:30 - Boat arrives / prepare plan with all parties to collect sediment samples:
 3 samples from damaged area
 2 samples from Toe of slope
 2 samples from approx 50 ft from Toe of slope
 13:30 - Start collecting sediment samples from areas
 Split samples as follows:
